**Flood Control Project Maintenance
Levee Inspections**

Fall 2013 Levee Maintenance Deficiency Summary Report

Sacramento River Basin

Sacramento Maintenance Yard Willow Slough Bypass

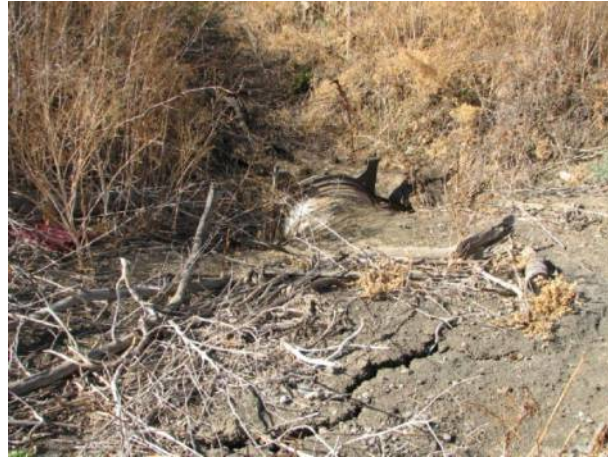
| Levee Mile Report Line | 4 |

| Waterway | | | | | | | Bank | Unit Miles | Inspection Start/End | Inspector | |
|---|---|---|---|---|---|---|--|---|---|---|--|
| 4 | 0.00 | 0.00 | Supplemental | DWR UCIP Field Study | LS | M En | Inspector Comments: FS_ID:6118 EP_NO: 10130 Repair Type: Non-Urgent Crossing Status: Found UCIP Comments: Minor debris blocking flap gate. Debris/log needs to be removed from the outlet. FIELD_STRUCT_DESC: 36-inch corrugated metal pipe through the levee 18.0 feet below the crown, flap gate on waterward end. Originally included in O+M manual (1952). FS Date: 9/19/2012 | 38.590766 ° -121.665560 ° | 38.590766 ° -121.665560 ° | 2 Y | |

Waterside view- pipe view from levee crown.

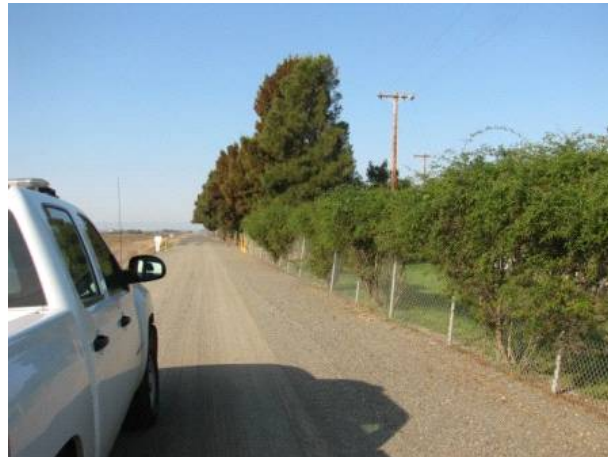
| Levee Mile Report Line | 6 |

| Waterway | | | | | | | Bank | Unit Miles | Inspection Start/End | Inspector | |
|---|---|---|---|---|---|---|--|---|---|---|--|
| 6 | 0.02 | 0.15 | Earthen Levee | Vegetation | CR | M En | V6 : Landscaping Inspector Comments: This is the treatment plant's landscaping and chain link fence. | 38.590742 ° -121.665767 ° | 38.590716 ° -121.668203 ° | 1 Y | |

The treatment plant's landscape and fence. This runs along the crown and toe of the levee.

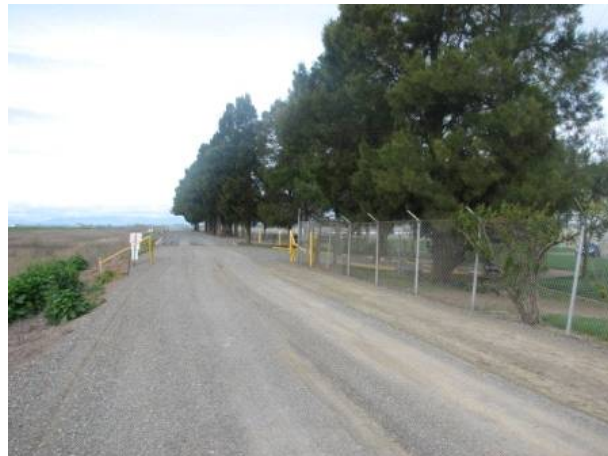
| Levee Mile Report Line | 6 |

Photo taken spring 2012, the treatment plants landscaping.

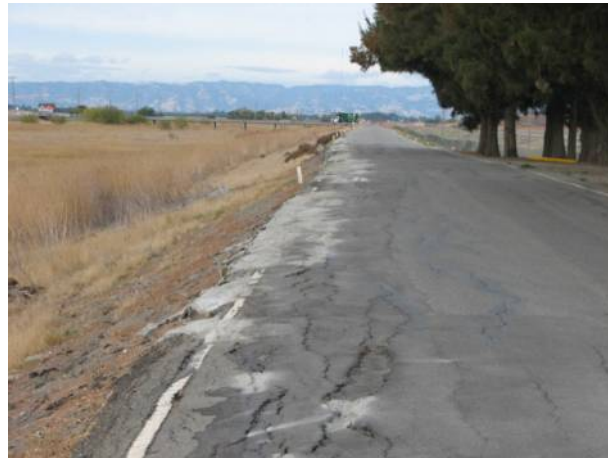
| Levee Mile Report Line | 7 |

| Waterway | | | | | | | Bank | Unit Miles | Inspection Start/End | Inspector | |
|---|---|---|---|---|---|---|--|---|---|---|--|
| 7 | 0.07 | 0.21 | Earthen Levee | Cracking | WS | M Ob | CR1 : Monitor and have inspected by geotechnical engineer. | 38.590724 ° -121.666749 ° | 38.590663 ° -121.669190 ° | 10 Y | |

There is still cracking sloughing on the waterside crown. Attempts to fill in the cracks all along the roadway have been done.

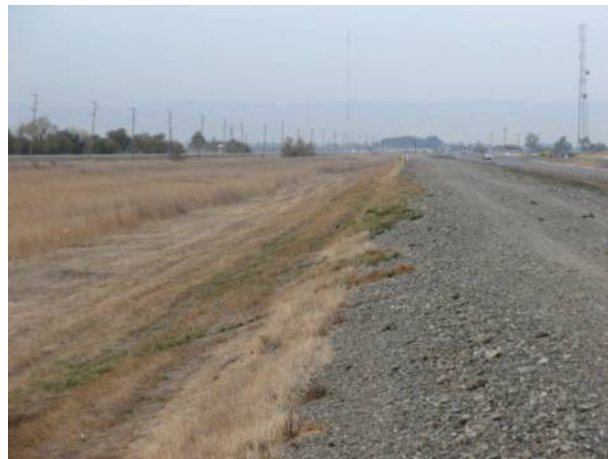
| Levee Mile Report Line | 8 |

| Waterway | | | | | | | Bank | Unit Miles | Inspection Start/End | Inspector | |
|---|---|---|---|---|---|---|--|---|---|---|--|
| 8 | 0.67 | 5.04 | Earthen Levee | Vegetation | WS | A Ma | V1 : Control annual grass and weeds on the levee slopes and easements. | 38.590505 ° -121.677663 ° | 38.600002 ° -121.752677 ° | 3 Y | |

The levee has no unwanted vegetation on the slope. Fall 2013

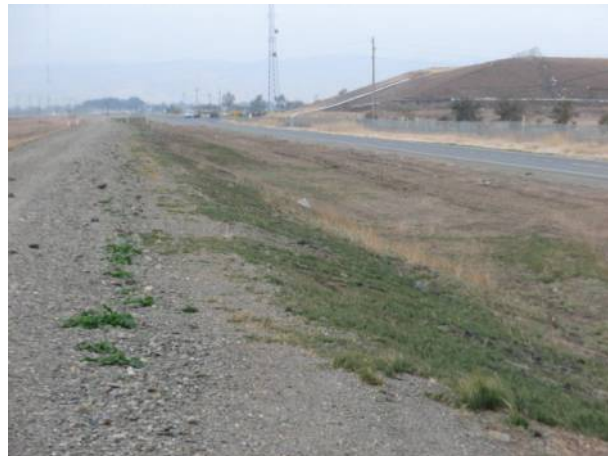
| Levee Mile Report Line | 9 |

| Waterway | | | | | | | Bank | Unit Miles | Inspection Start/End | Inspector | |
|---|---|---|---|---|---|---|--|---|---|---|--|
| 9 | 0.67 | 5.04 | Earthen Levee | Vegetation | LS | A Ma | V1 : Control annual grass and weeds on the levee slopes and easements. | 38.590502 ° -121.677667 ° | 38.600002 ° -121.752660 ° | 5 Y | |

The levee has no unwanted vegetation on the slope. Fall 2013

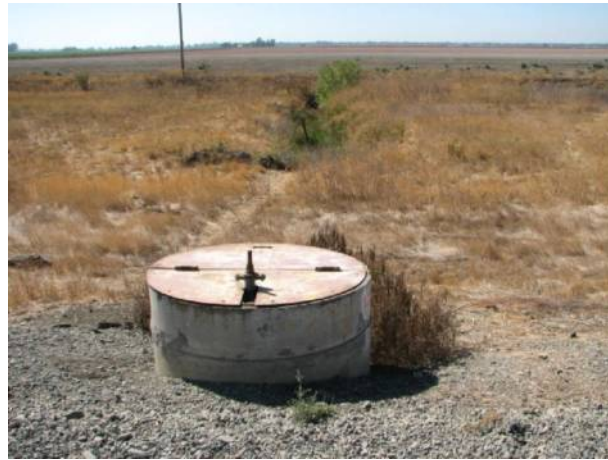
Waterside overview

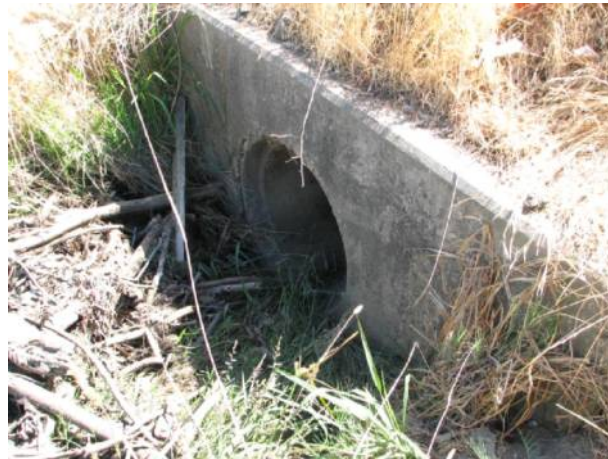
| Levee Mile Report Line | 12 |

| 12 | 2.02 | 2.02 | Supplemental | DWR UCIP Field Study | LS | M En | Inspector Comments: FS_ID:6264 EP_NO: 10307 Repair Type: Non-Urgent Crossing Status: Found UCIP Comments: The 48-inch concrete manhole damaged - top ring knocked off in waterside. Debris found in waterside pipe. FIELD_STRUCT_DESC: 24-inch pipe through the levee, 10.0 feet below the crown. Flap gate on the waterward end. Concrete headwall on both ends. Slide gate in 48-inch manhole on WS slope. (A.B.O. No. 10307 - Beckman). O&M manual 120, revision Dec 2010. FS Date: 9/19/2012 | 38.590390 ° -121.702470 ° | 38.590390 ° -121.702470 ° | 14 Y |

Landside view- concrete pipe and headwall.

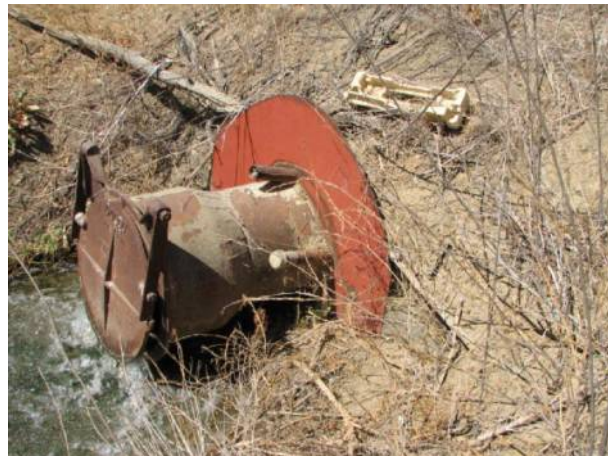
| Levee Mile Report Line | 14 |

| 14 | 2.02 | 2.02 | Supplemental | DWR UCIP Field Study | LS | M En | Inspector Comments: FS_ID:6144 EP_NO: 9253A Repair Type: Non-Urgent Crossing Status: Found UCIP Comments: Needs vegetation removal on landside of the levee. FIELD_STRUCT_DESC: A 20-inch pipe sleeved through 30-inch pipe and angular space grouted, through the levee, 9.0 feet below the crown. Slide gate on the waterward slope in 48-inch standpipe. Concrete headwall on both ends. Flap gate in the waterward headwall. (App. No. 9253-A - Yolo County) FS Date: 9/19/2012 | 38.590390 ° -121.702540 ° | 38.590390 ° -121.702540 ° | 16 Y |

Waterside view- pipe was working during field survey. Pipe and flap gate.

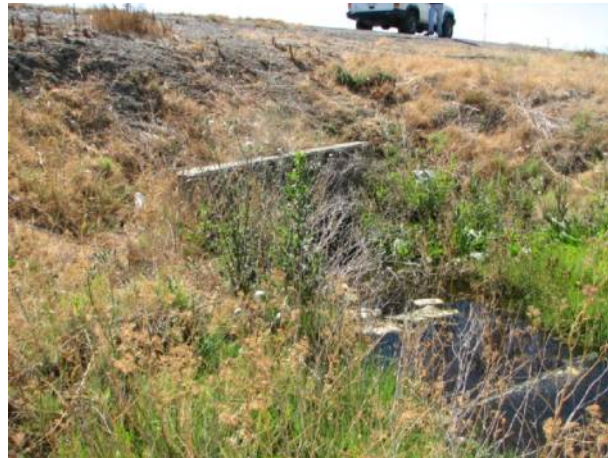
Landside view- inlet structure

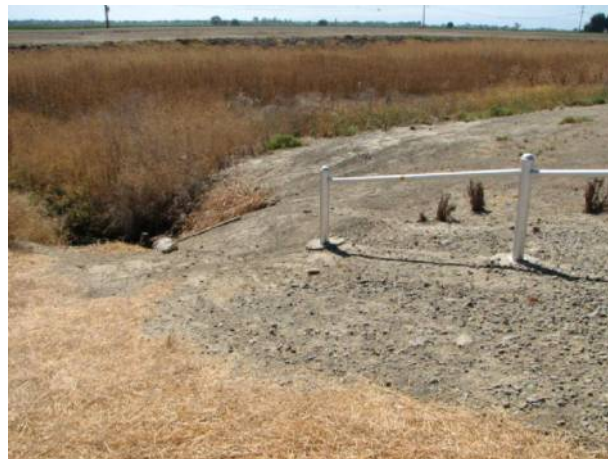
| Levee Mile Report Line | 16 |

| 16 | 3.56 | 3.56 | Supplemental | DWR UCIP Field Study | LS | M En | Inspector Comments: FS_ID:6165 EP_NO: 10316 Repair Type: Non-Urgent Crossing Status: Found UCIP Comments: Debris on waterside flap gate. Needs debris removal from the pipe. FIELD_STRUCT_DESC: 24-inch CM drainpipe through the levee, 11.0 feet below the crown. Flap gate on the waterward end. Waterside pipe sits on concrete saddle. (A.B.O. No. 10316 - Stafford). O&M manual 120, revision Dec 2010. FS Date: 9/19/2012 | 38.590680 ° -121.730720 ° | 38.590680 ° -121.730720 ° | 18 Y |

Waterside view- overview

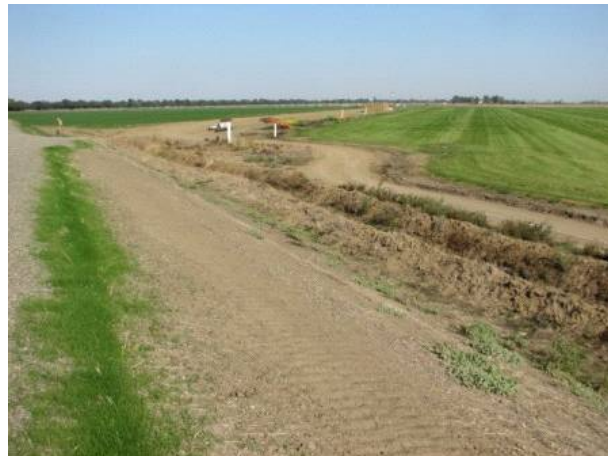
| Levee Mile Report Line | 18 |

| LMR No. | Levee Mile | | Category | Item | Location | Rating | Action/Comment | GPS Latitude/Longitude | | Issue No. |
|---|---|---|---|---|---|---|---|---|---|---|
| 18 | 4.32 | 4.63 | Earthen Levee | Encroachments | LS | M En | DT : Ditch | 38.598876 ° -121.739640 ° | 38.599845 ° -121.745007 ° | 4 Y |

The agricultural ditch runs along the toe of the levee. Fall 2011

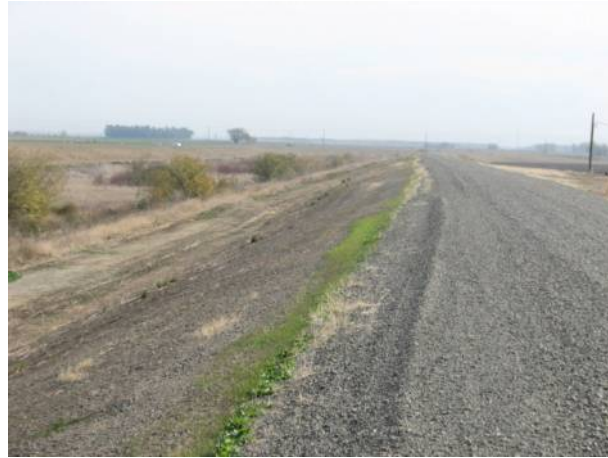
The levee has no unwanted vegetation on the slope. Fall 2013

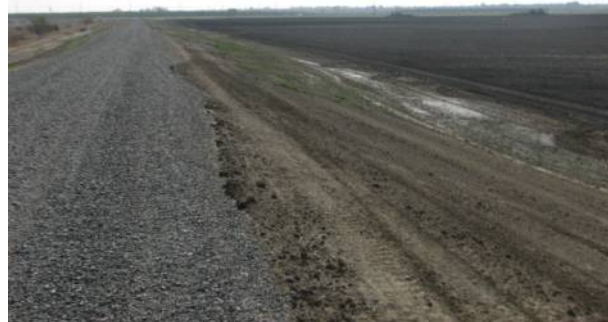
| Levee Mile Report Line | 3 |

The levee has no unwanted vegetation on the slope. Fall 2013

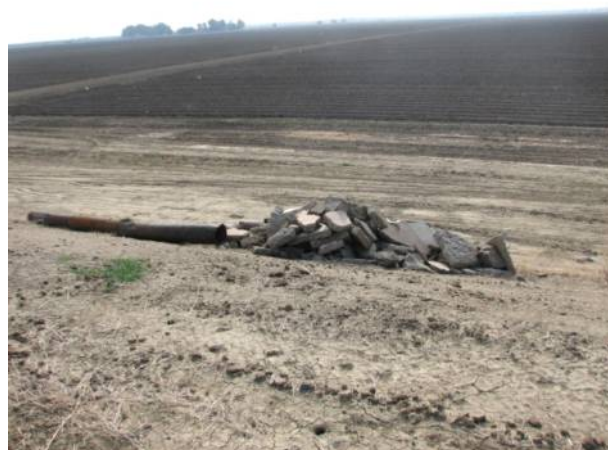
| Levee Mile Report Line | 4 |

There is some debris pipe and concrete on the levee slope. Fall 2013

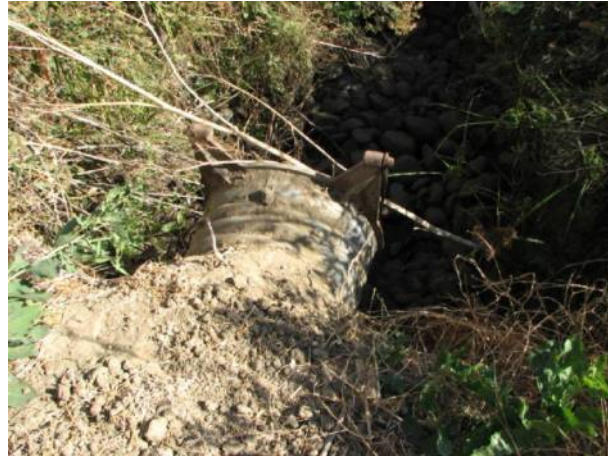
Waterside view- CM pipe and flap gate.

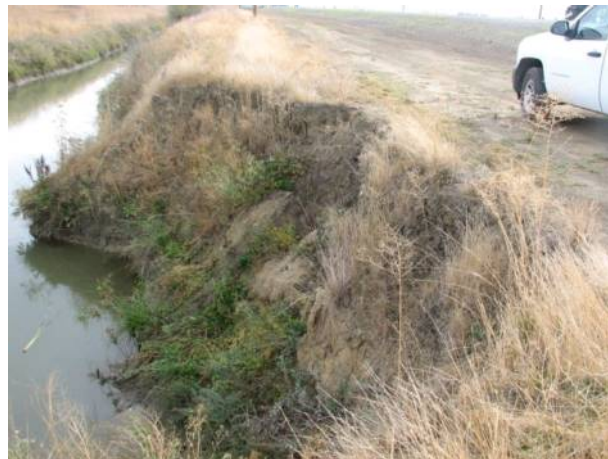
| Levee Mile Report Line | 6 |

Erosion on the edge of the channel. Fall 2012

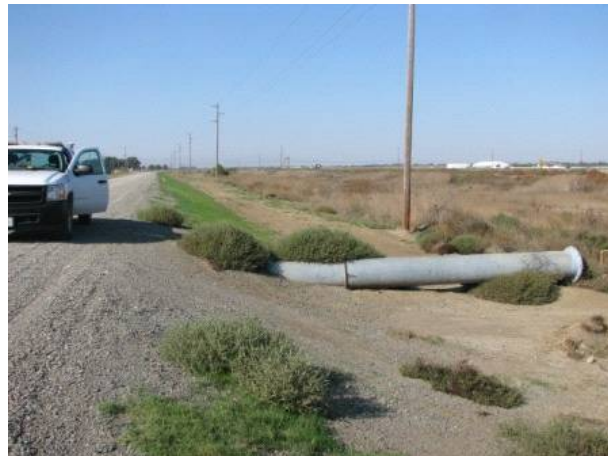
| Levee Mile Report Line | 7 |

A pipe crossing thru the levee and blocking toe road. Fall 2011

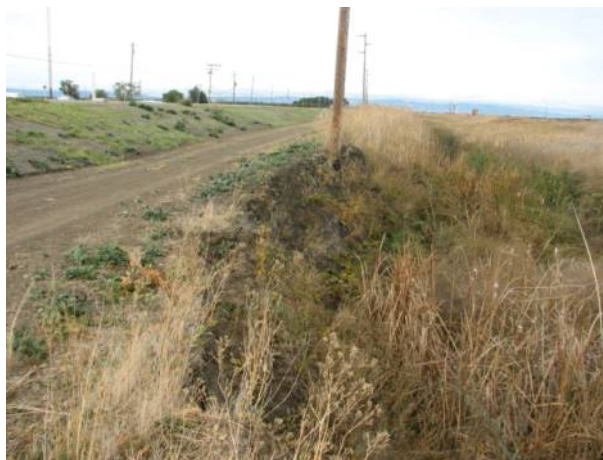
Erosion on the edge of the channel. Fall 2012.

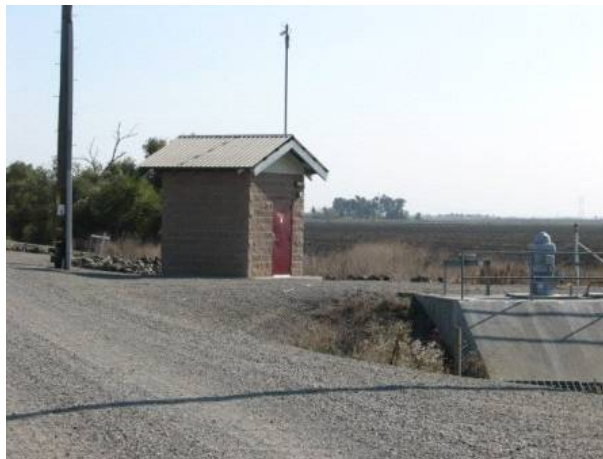
| Levee Mile Report Line | 12 |

A control structure is placed on top of the levee. Fall 2011

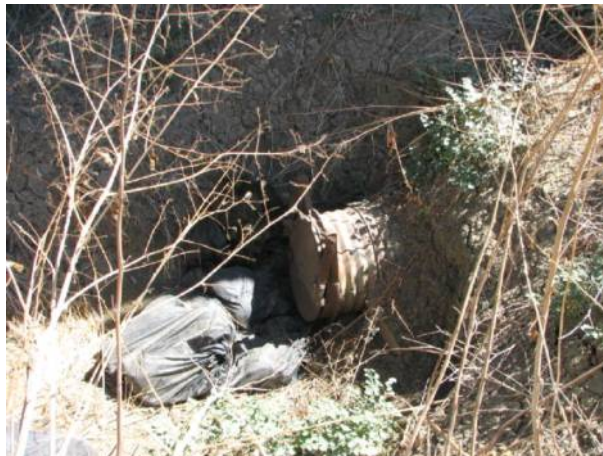
| Levee Mile Report Line | 16 |

| LMR No. | Levee Mile | | Category | Item | Location | Rating | Action/Comment | GPS Latitude/Longitude | | Issue No. Photo |
|---|---|---|---|---|---|---|---|---|---|---|
| 16 | 4.53 | 4.53 | Supplemental | DWR UCIP Field Study | LS | M En | Inspector Comments: FS_ID:13877 EP_NO: 10319 Repair Type: Non-Urgent Crossing Status: Found UCIP Comments: Material removed from inlet last fall. Outlet cleared FIELD_STRUCT_DESC: 24-inch CM drainpipe through the levee, 15.0 feet below the crown. Flap gate on the waterward end. (A.B.O. No. 10319 - Bell). O&M manual 120, revision Dec 2010. FS Date: 5/24/2013 | 38.589575 ° -121.674950 ° | 38.589575 ° -121.674950 ° | 159 Y |

Waterside view- pipe and flap gate.
